Mapping Earthen Berms in the Meadowlands

Soft Edges Around the Hackensack River Watershed

New Jersey Meadowlands Commission
Meadowlands Environmental Research Institute
Geographical Information Systems Department
1 DeKorte Park Plaza
Lyndhurst NJ, 07071

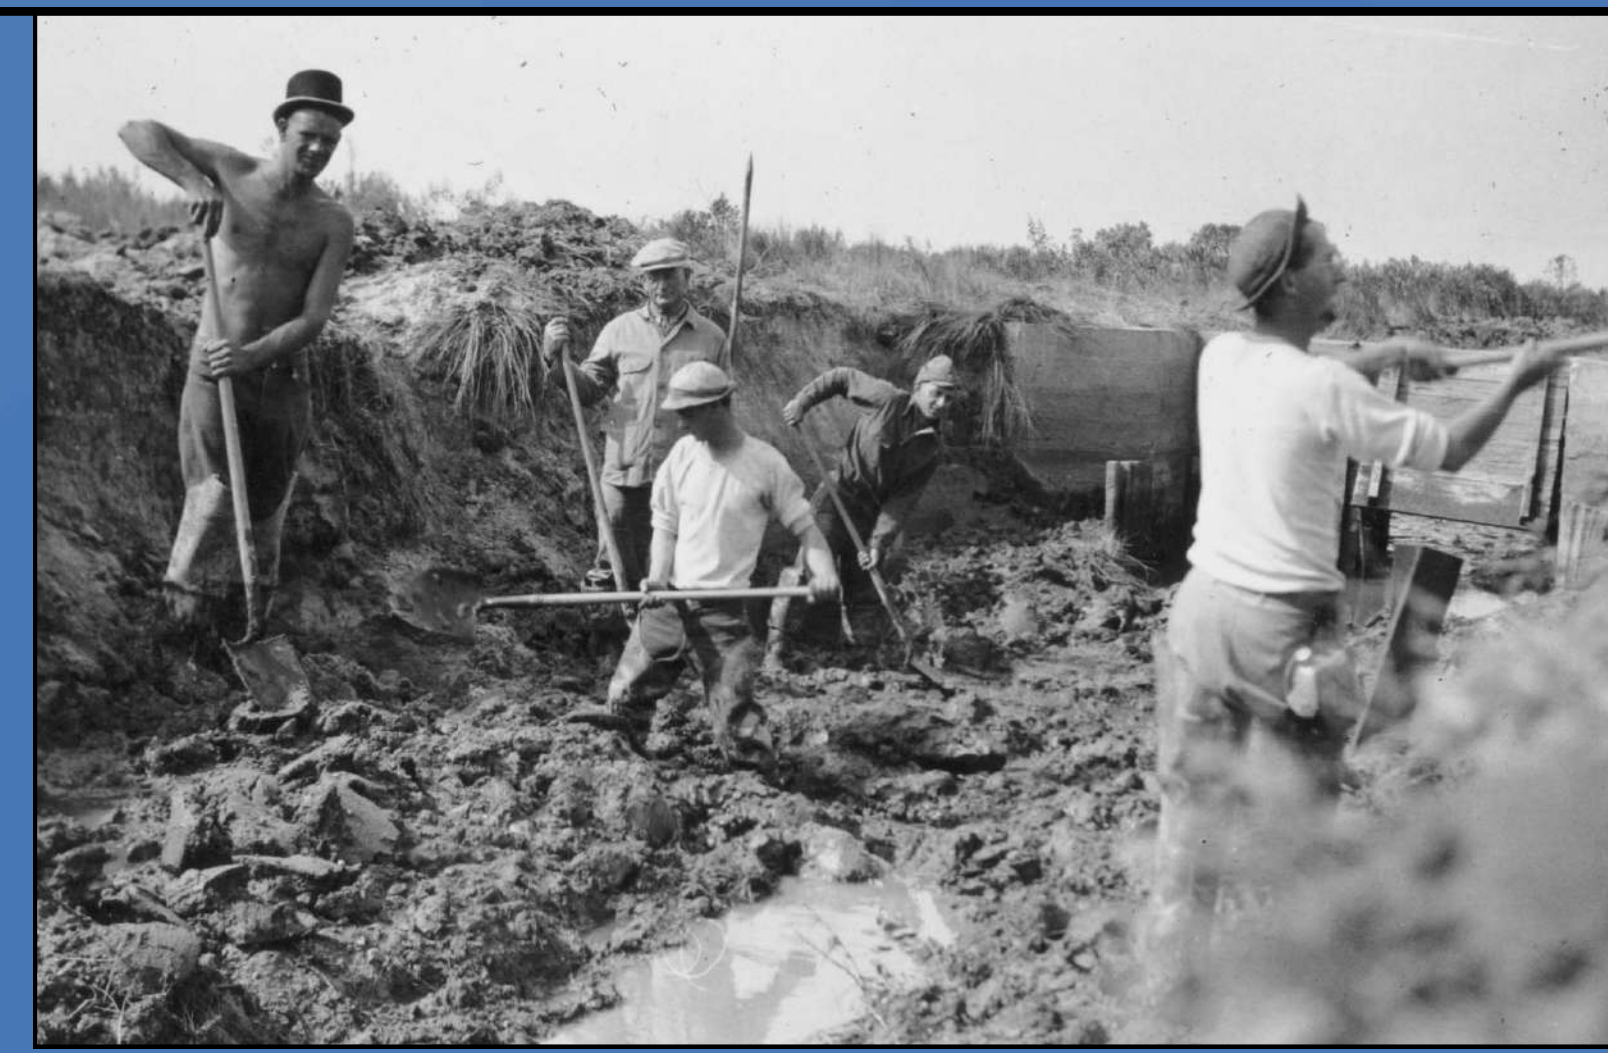
Early ditching efforts by the Mosquito Commission resulted in berms around the Meadowlands and are found throughout the Hackensack River Estuary. These earthen man-made berms were not intended to be flood control structures. In events such as a storm surge these structures are susceptible to overtopping.

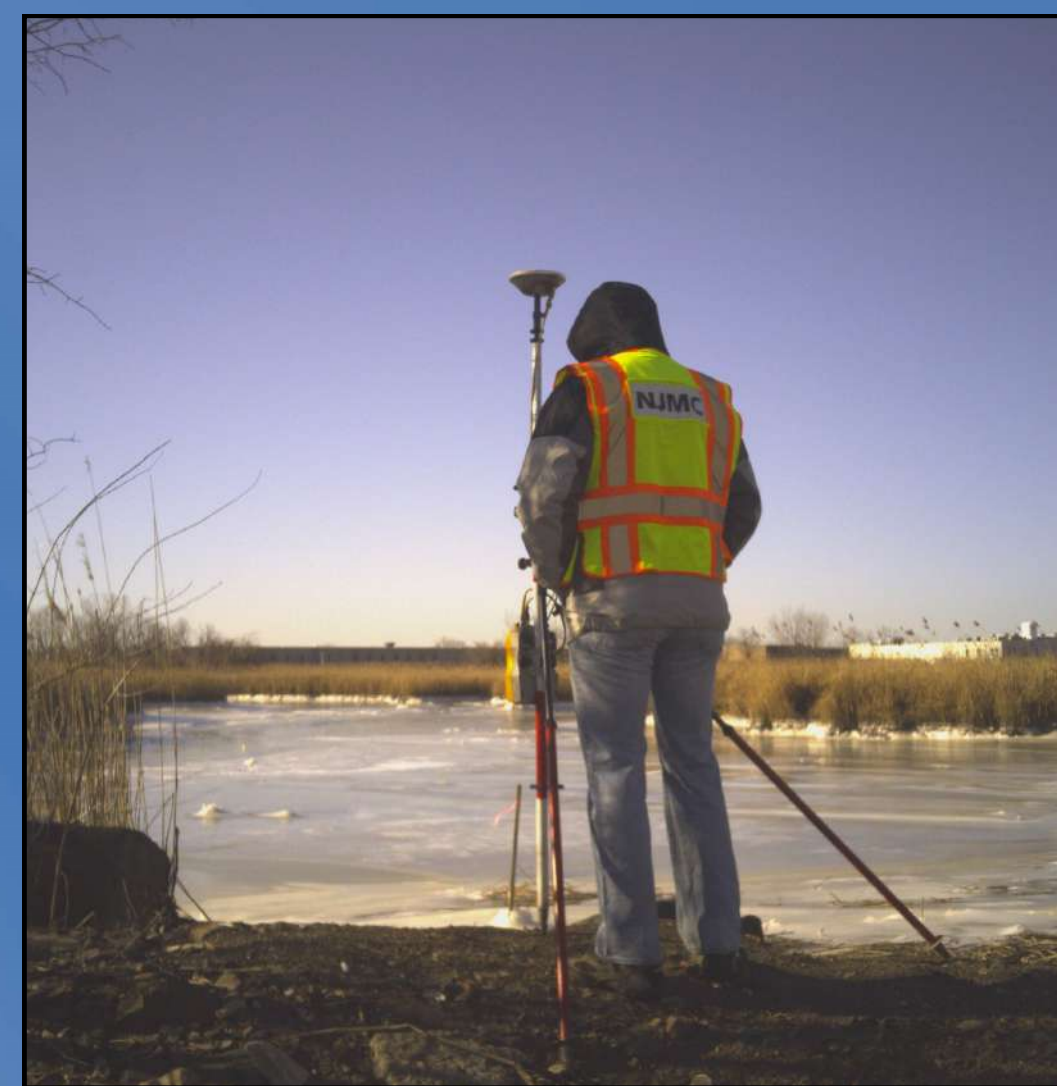
Elevations were taken along the known berms. This effort was to understand the heights of these structures that were overtopped by Superstorm Sandy.

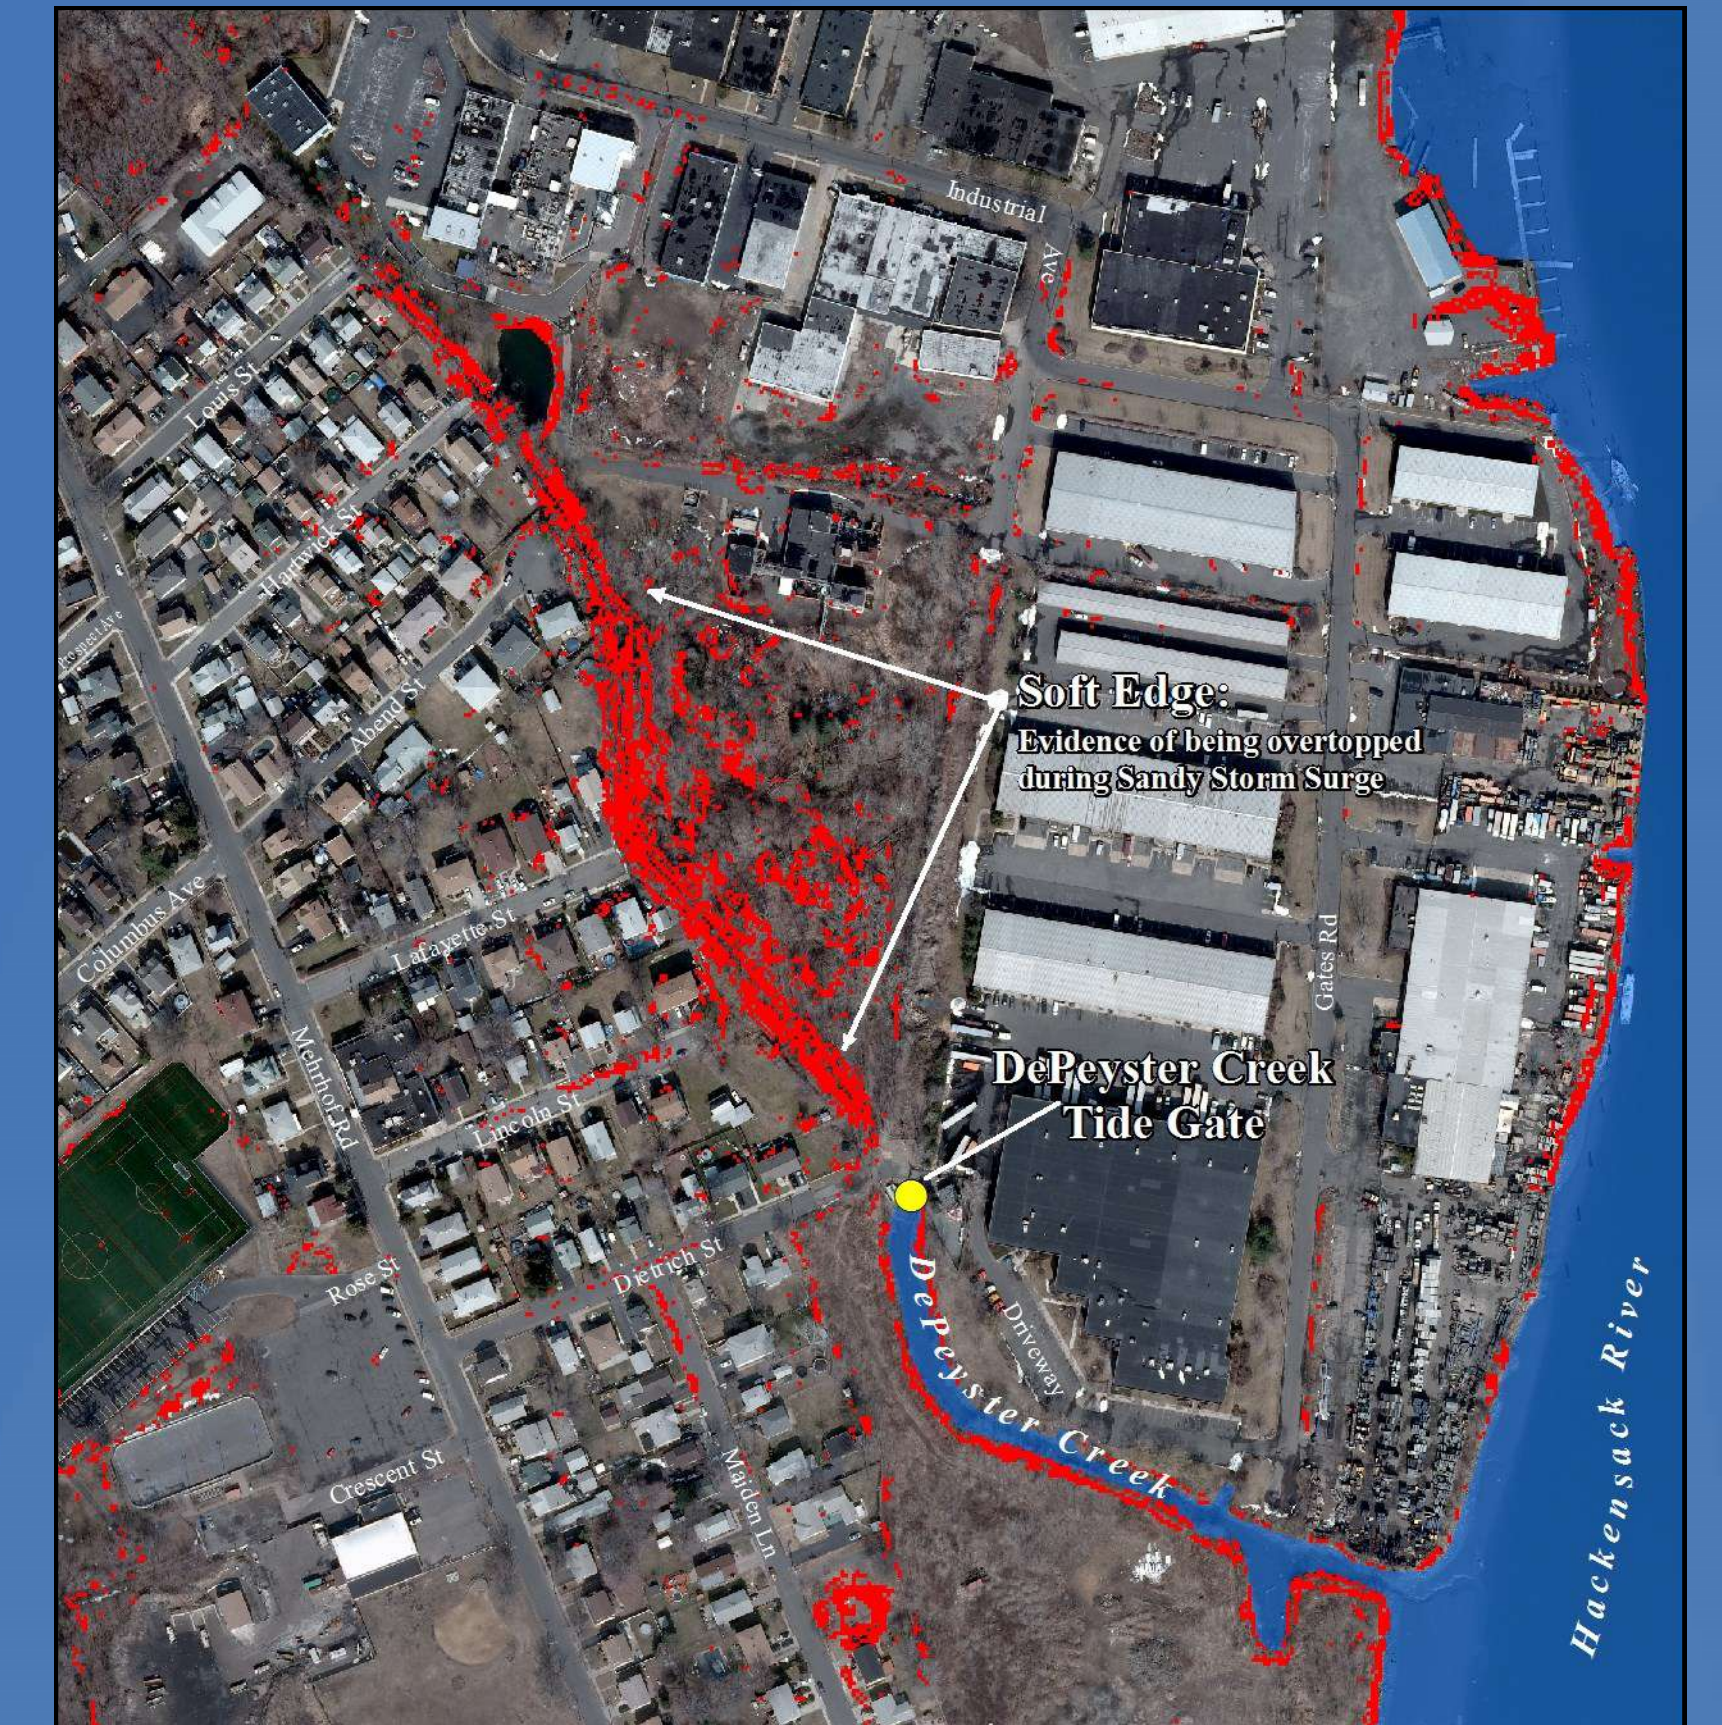
Results:

Pictured above is the result of the classifications; a known soft edge in red was overwhelmed during the Sandy storm surge. The soft edge is along a section of DePeyster Creek in Little Ferry adjacent to a residential area. The residents in this area experienced 3 feet of flooding in this neighborhood. The definition of the classification in red is top of berm with elevations below 5 feet.
